**Thompson River Forest Highway Proposal
Aquatic and Hydrologic Assessment of the
Thompson River Corridor – Road MP 0.0 to 42.6**

**Final Report
April 2008**

Final Report Prepared by:
Amy Beussink, Hydrologist
Traci Sylte, P.E., Hydrologist
Amy Groen, Hydrologic Technician

**USDA Forest Service
Lolo National Forest
Building 24, Fort Missoula
Missoula, MT 59804**

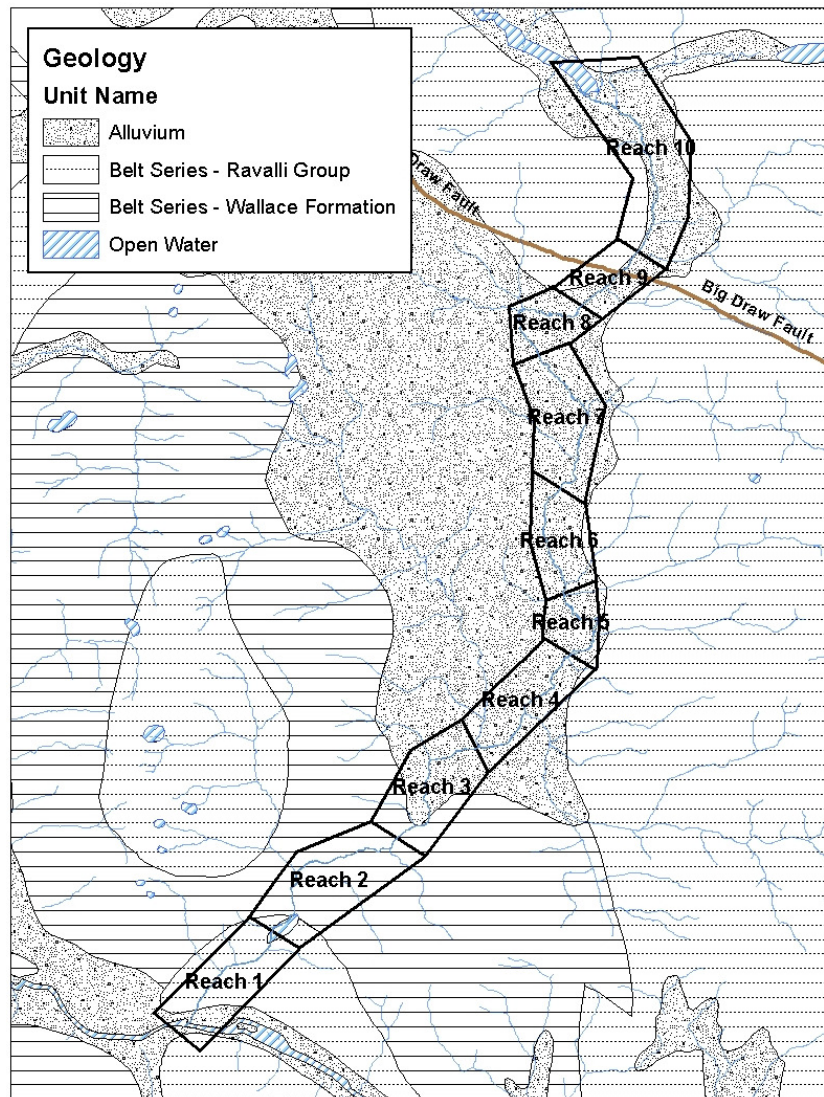
Figure 3. Geology of the Thompson River area (1:500,000)

The underlying geology of the upper half of the Thompson River valley is lower metasedimentary Belt rocks which have broadened into a wide valley as a result of glaciation while the lower half has more bedrock outcrop influence from upper Belt rocks. The lower valley is narrower than the upper valley. On top of this underlying geology, quaternary alluvium overlies the upper three quarters (from the middle of Reach 3 up through Reach 10). The Big Draw Fault intersects the valley from southeast to northwest across Reach 9. Across the middle of Reach 3 the alluvium deposits contact with the Wallace Formation Belt rocks that persist through much of Reach 2. The Wallace Formation Belt rocks then contact the Ravalli Group Belt rocks in lower Reach 2 and throughout Reach 1 (Figure 3).

The influence of geology on water temperature may be partially driving fish population distributions. Warmer temperatures upstream of mile 18 may be a result of the shallow aquifer within the alluvial deposits filling the valley floor. Deeper, cooler water in the alluvial aquifer is forced to the surface as the bedrock shallows toward the contact between the alluvial deposits and the Wallace formation.

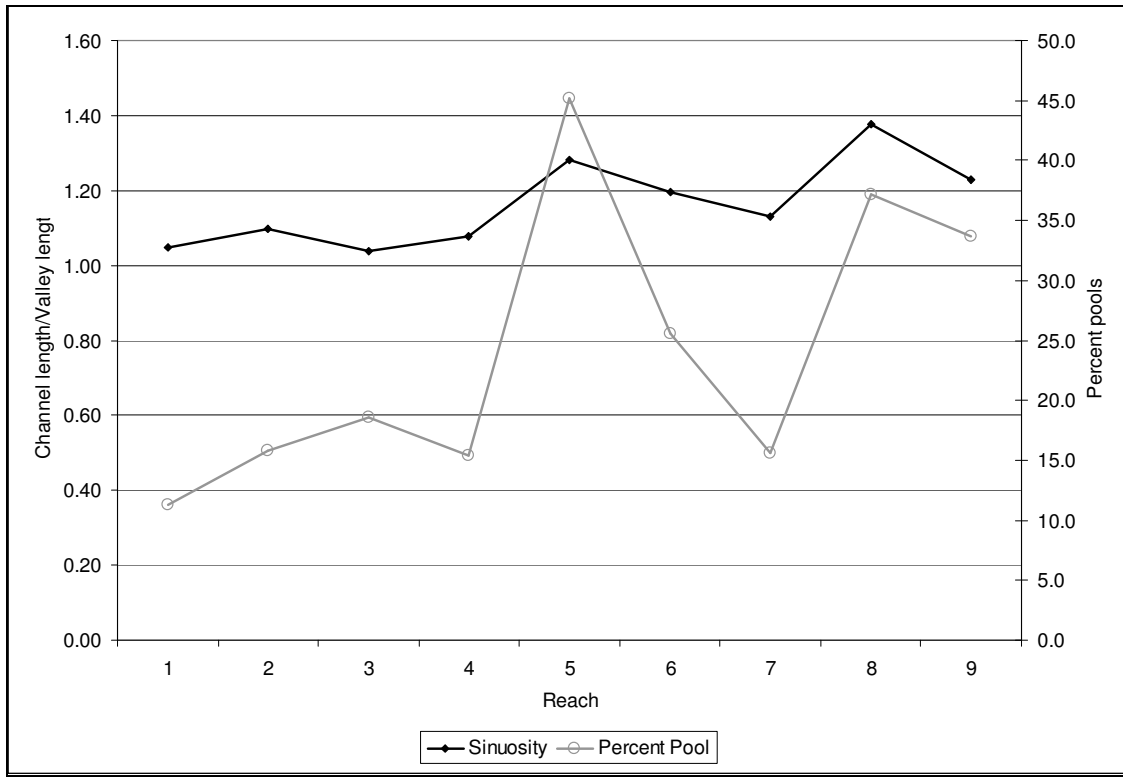
Figure 4. Existing (2000) relationship between sinuosity (channel length/valley length) and percent pools.

Figure 4 displays a positive correlation between sinuosity and percent pools: the more sinuous the stream, the greater number of pools. Figure 5 shows that 3 of the 5 reaches analyzed in the 1940's and again in 2000 (Reaches 1, 3, and 4), decreased in sinuosity (reduced channel length). Of the other 2 reaches analyzed, one increased in sinuosity (Reach 6) and the other remained relatively unchanged (Reach 2). By combining the relationships displayed in Figures 4 and 5, it can be inferred that less sinuous channel conditions in reaches 1, 3, and 4 today (2000) are associated with reduced pool habitat. Increased sinuosity in Reach 6 appears to be a result of lateral channel migration and point bar development, overall channel lengthening, and is associated with relatively high percent pools. (See also Figures 14-18).

Channel sinuosity changes were correlated to the observed changes in channel length. Overall, sinuosity decreased in Reaches 1 through 4 (Figure 4) with the calculated reduction closely related to road encroachment and meander truncations.

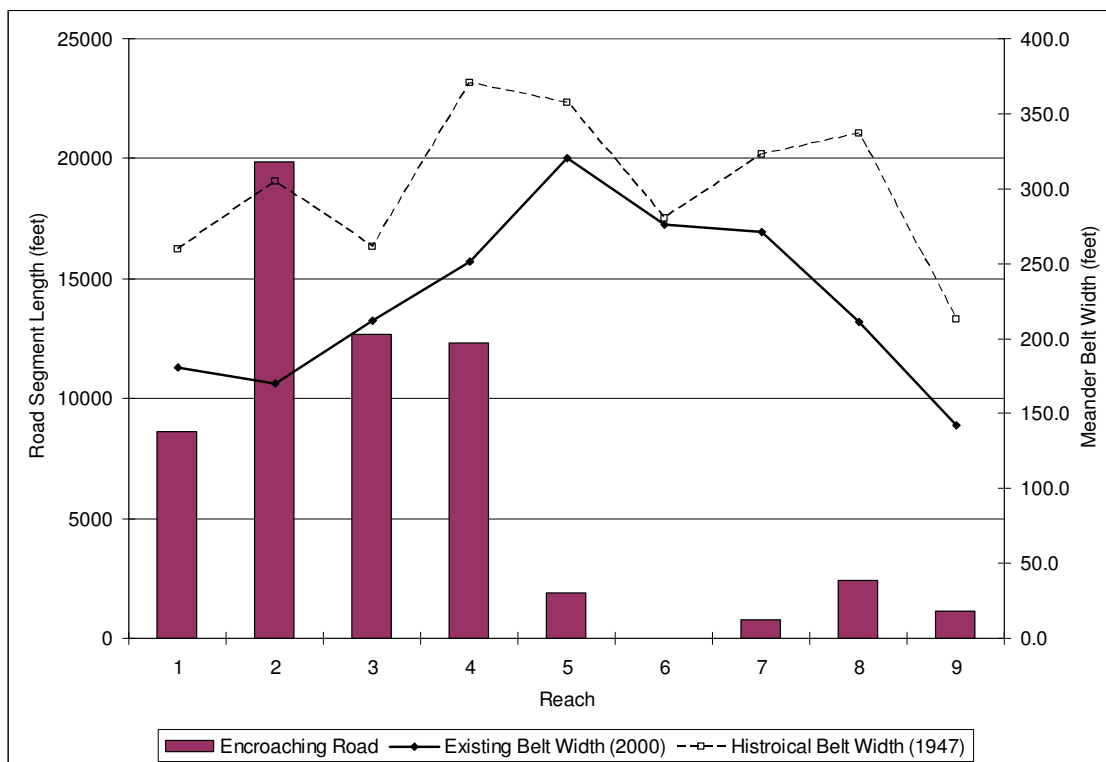
Figure 6. Length of encroaching road (road as stream bank) and associated mean meander belt width changes by stream reach.

Meander belt width has decreased in all reaches, reflecting increased confinement of the river corridor by roads (Figure 6). Percent decreases in average belt width per reach range from 1% (-4 feet) in Reach 6 to over 44% (-135 feet) in Reach 2. Mean belt width has been reduced by 30% or more in 5 reaches (Reaches 1, 2, 4, 8, 9). The greatest decreases in belt width are generally associated with the greatest length of road encroachment (road prism as stream bank).

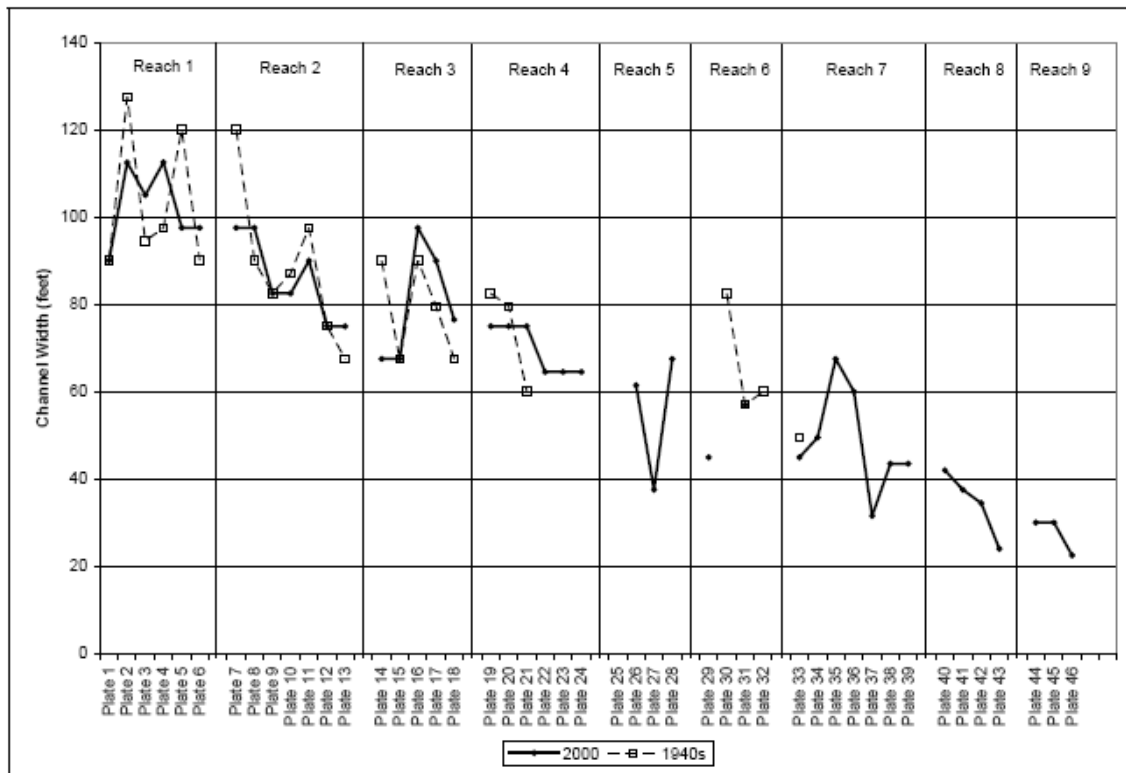
Figure 7. Average channel widths (excluding minimum and maximum values) are presented on the Y-axis for each photo plate on the X-axis. Values are grouped by Reach across the top.

Changes in channel widths have varied over time, as observed by reach and by photo plate (Figure 7). Overall, the analysis showed decreases in mean channel width from the historical photo series to the more recent photos (Reaches 1, 2, 4, 6 and 7). Decreases in mean channel width may be the result of increased stream power and channel incision. Mean channel width in Reach 3 increased slightly, although both increases and decreases in channel width were observed within the reach.

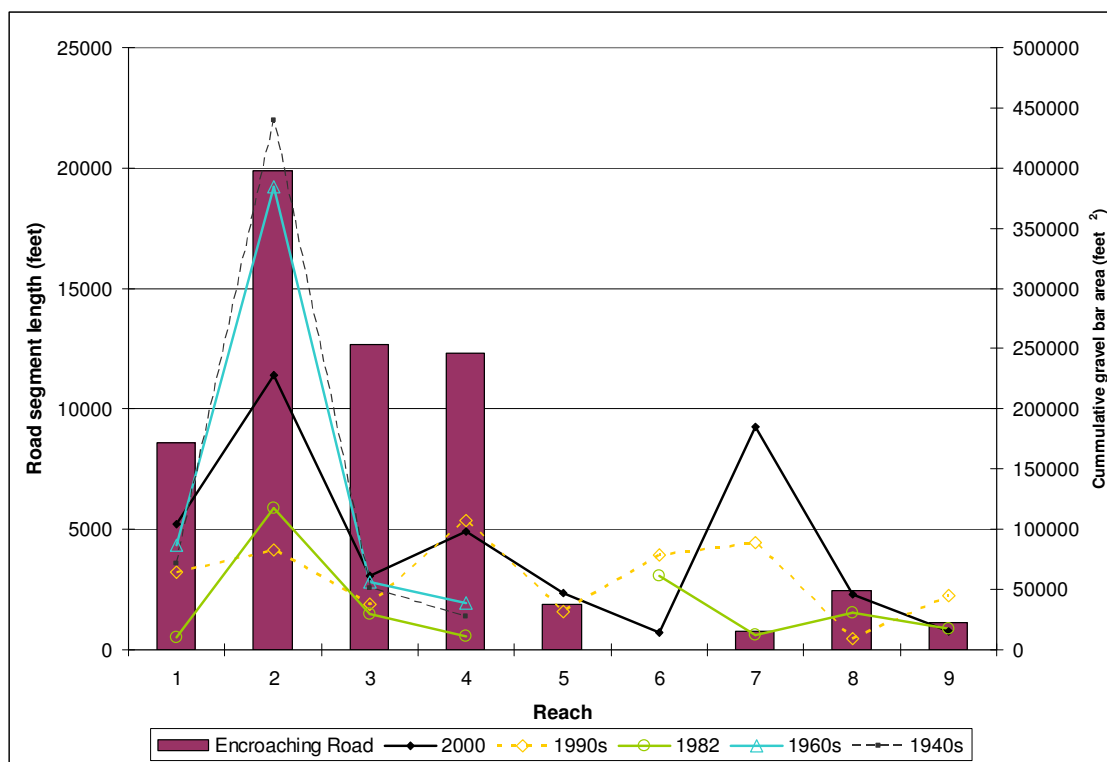
Figure 8. Length of encroaching road (road as stream bank) and associated deposition bar area.

Based on the 2000 photos, bars were concentrated in Reaches 4, 2, and 7 (Figure 8). A peak flow of 4,570 cfs in 2002 (Figure 9) likely mobilized the sediment observed in the 2000 aerial photo bars as well as recruited new sediment from the channel, banks, and tributaries. The 2002 flow was an 8.5 year flood event with a 12% exceedence probability (Figures 10 and 11).

From qualitative observations, areas of road encroachment upon the stream were frequently accompanied by areas of downstream deposition. This observation suggests that road encroachment has caused localized channel scour at the channel-road fill-slope interface, and downstream deposition of the scoured substrate.

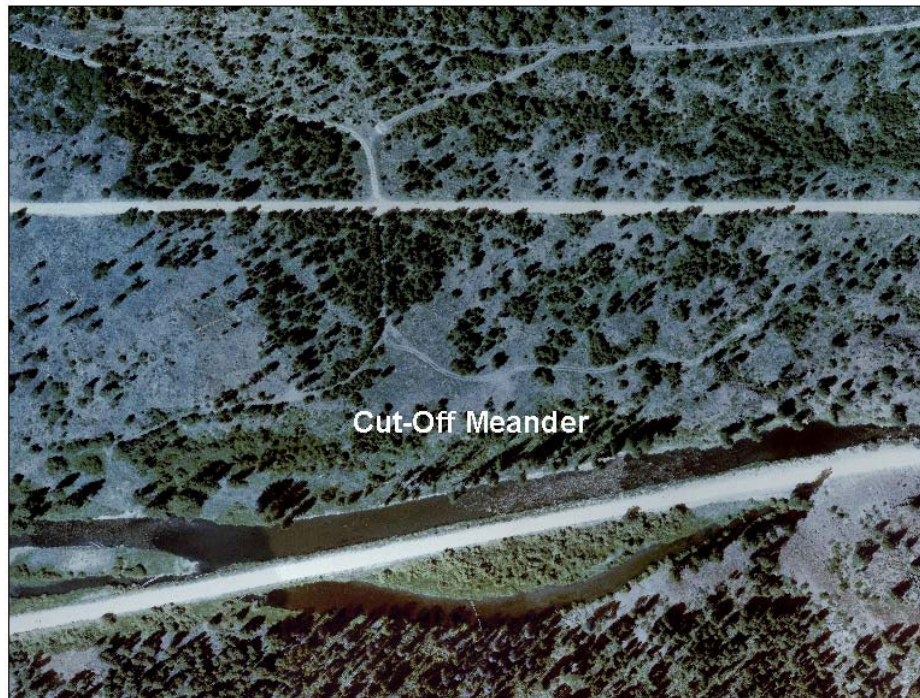
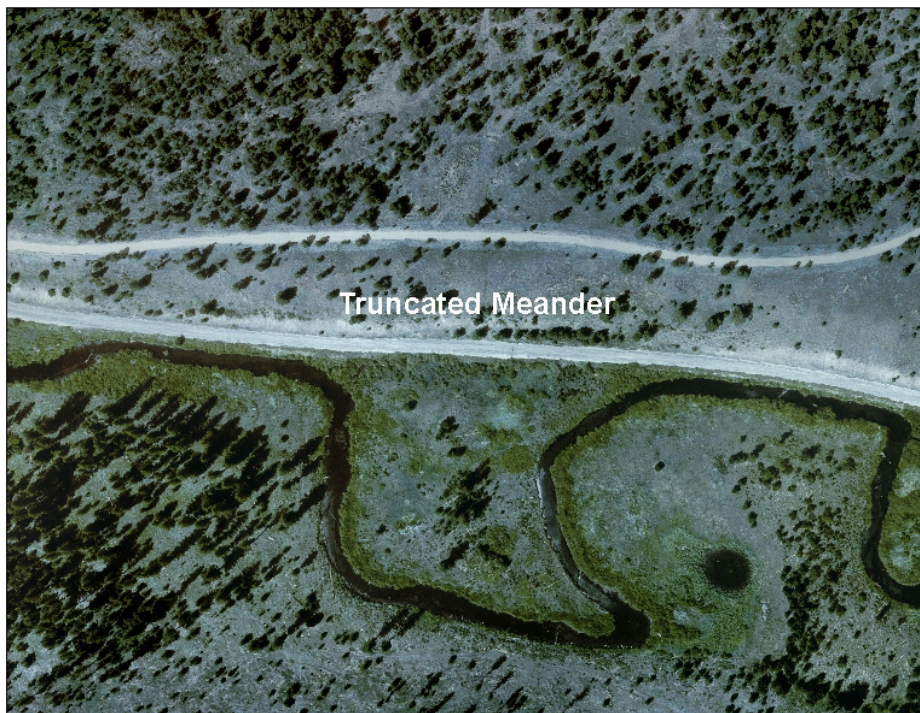
Figure 12. Cut-off meanders (top photo; bottom of Reach 4 near mile post 16) and truncated meanders (bottom photo; middle of Reach 8 above Bend) exemplify two adverse impacts of the existing road alignment on the Thompson River.

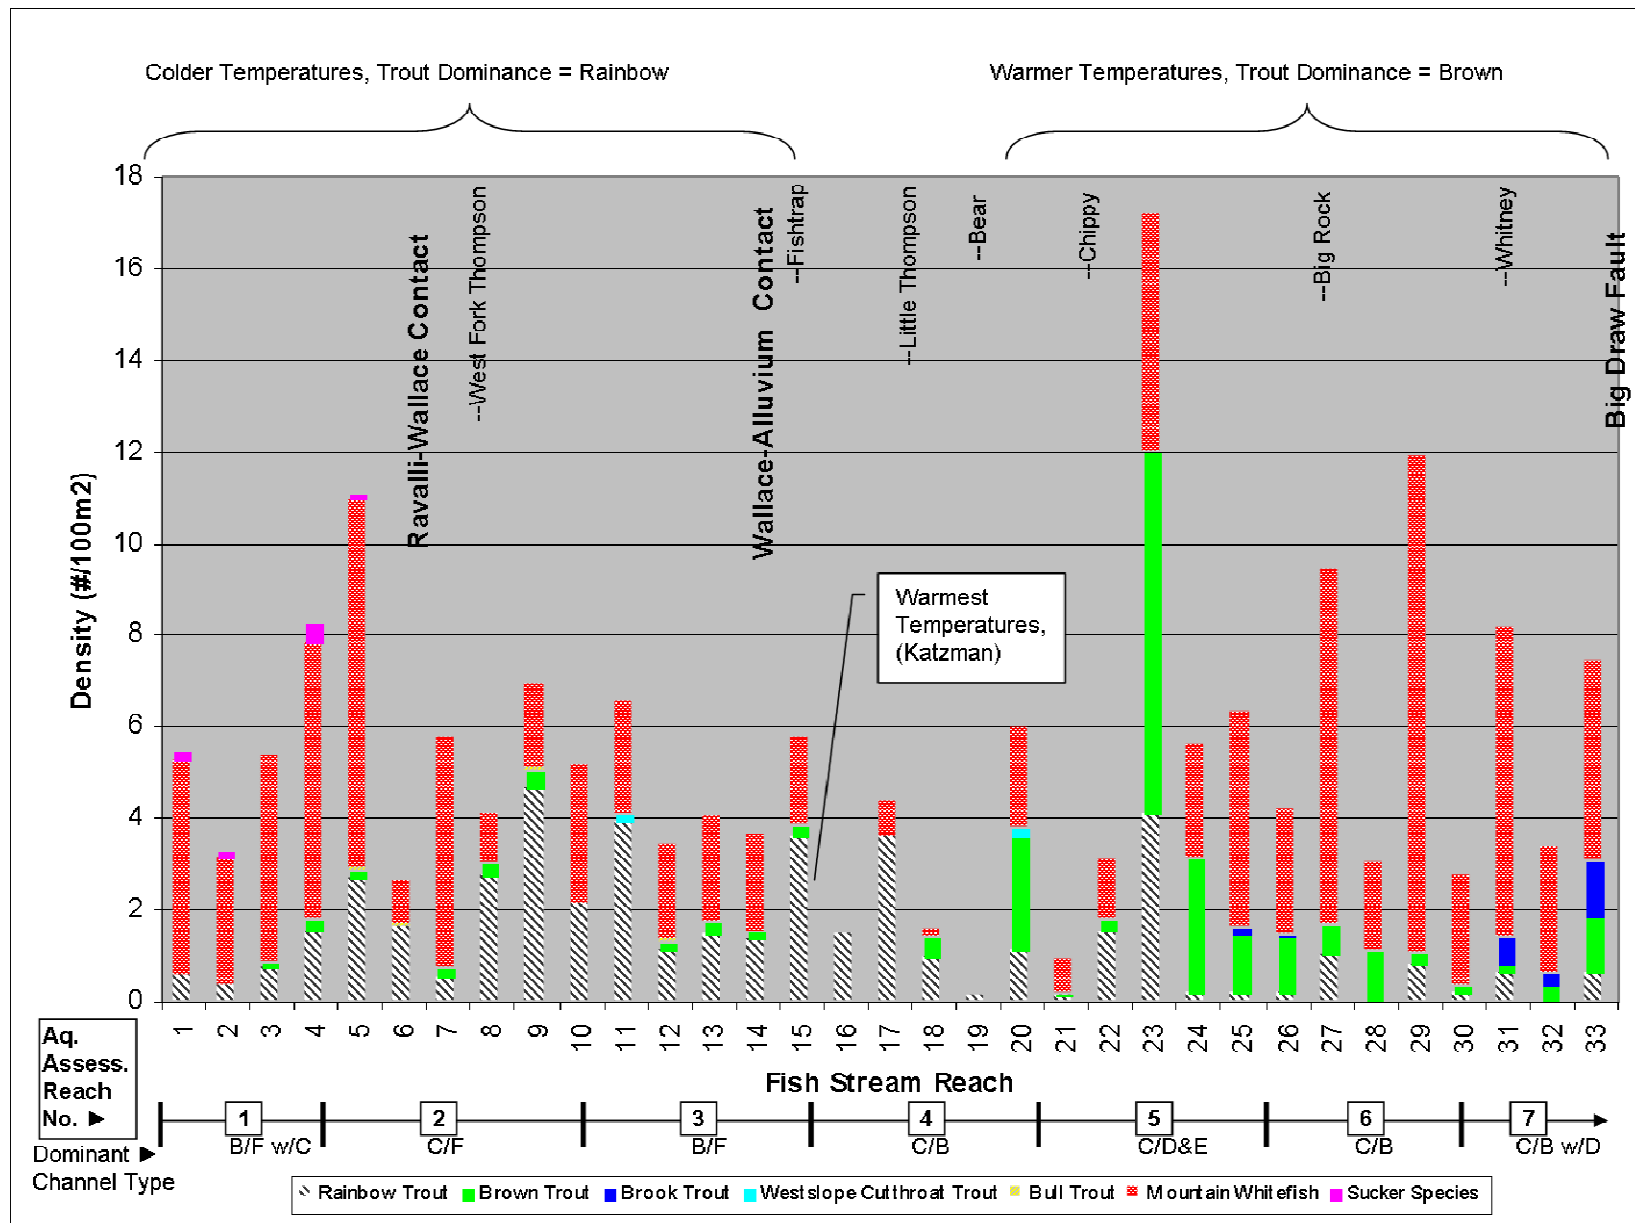
Figure 13. Fish density by surveyed reach with associated geomorphic features.

Native salmonids occur in low numbers in the Thompson River and their distribution is also limited (bull trout in 18% of habitat units surveyed and west slope cutthroat in 6%) (Table 9 and Figure 13). Native salmonids do not exist above stream mile 21. Native suckers are also limited to 13% of surveyed habitat units. Native mountain whitefish are abundant and occur in 94% of habitat units surveyed. Non-native fish are common and widely distributed throughout the Thompson River: rainbow trout were found in 93% of surveyed units, mostly from stream mile 1-23, and brown trout in 81% of units, mostly from stream mile 20-33. Brook trout were only found in the upper 5 miles of the survey.

Highest fish densities in the Thompson River were found above stream mile 18, where the impact from the dual road system is less than in the lower drainage; however, the relationship is not statistically significant. Most fish are small (< 300 mm) juveniles. The greatest sinuosity (channel length) and greatest percent pools are found in Reach 5 where the highest fish density is found.

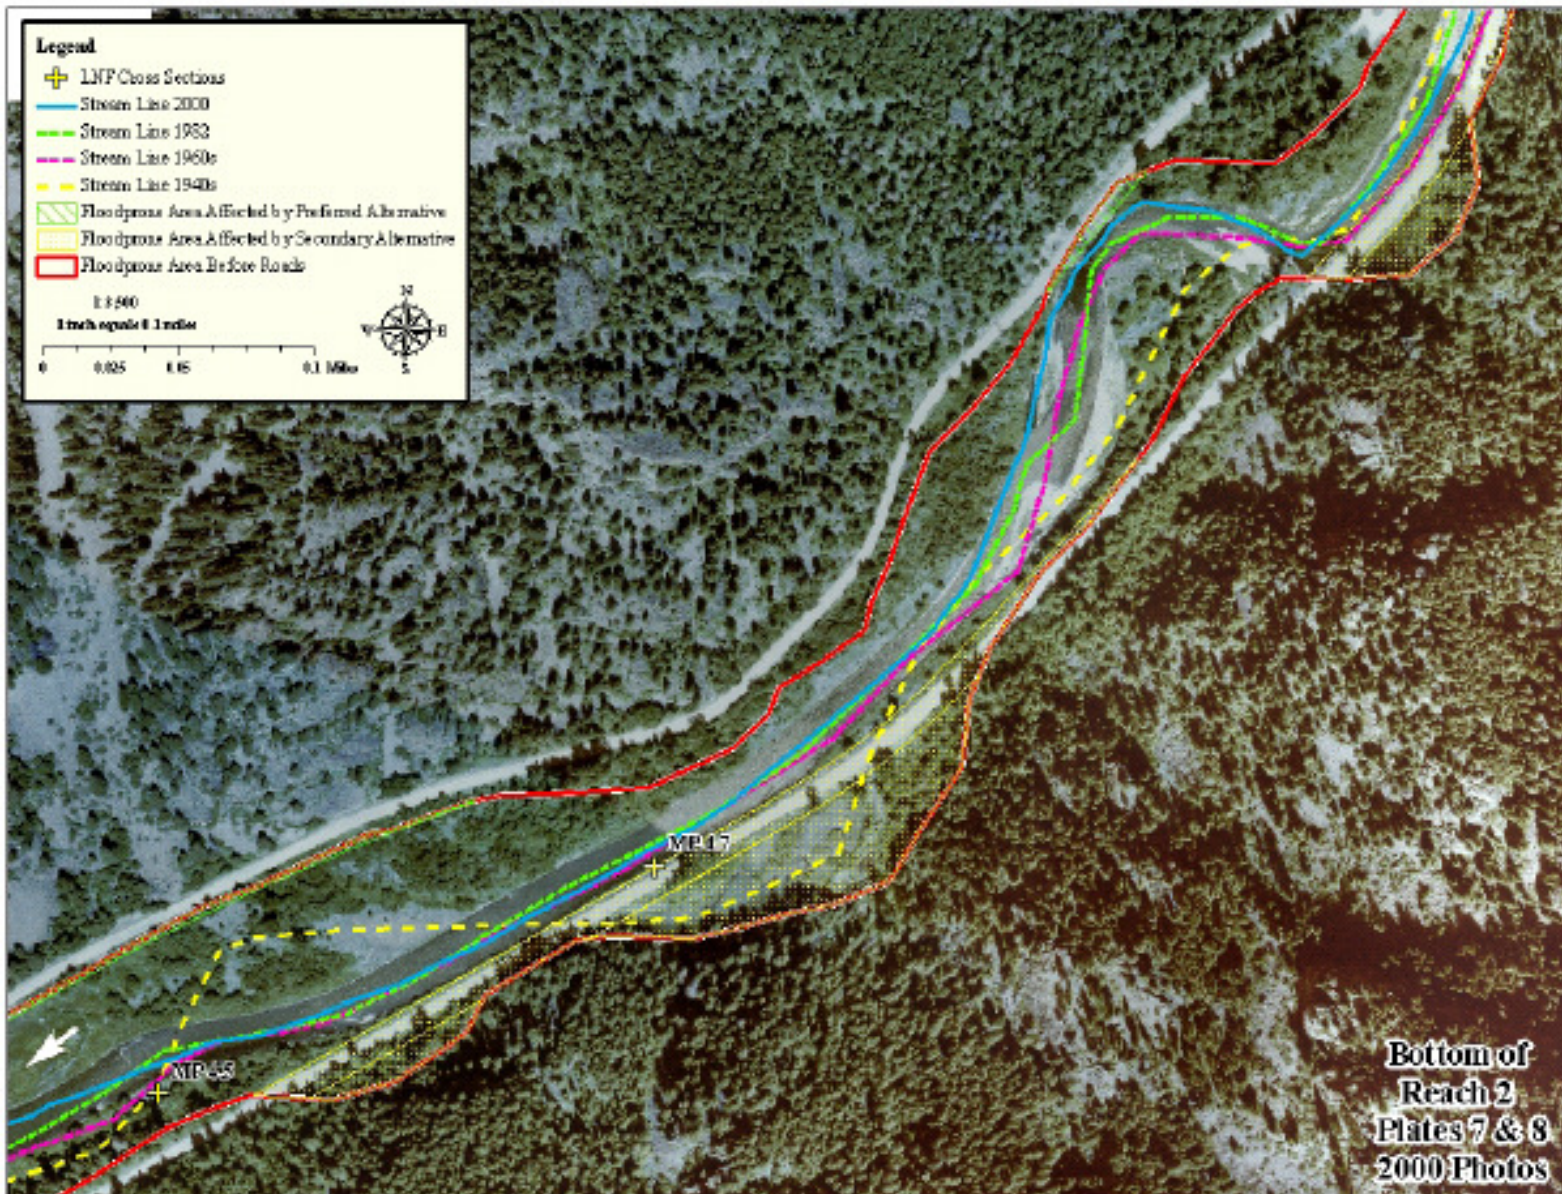
Figure 14. Channel changes and meander cut-offs in Reach 2 below the West Fork Thompson River. See also Figure 4 in Channel Morphology Analysis report.

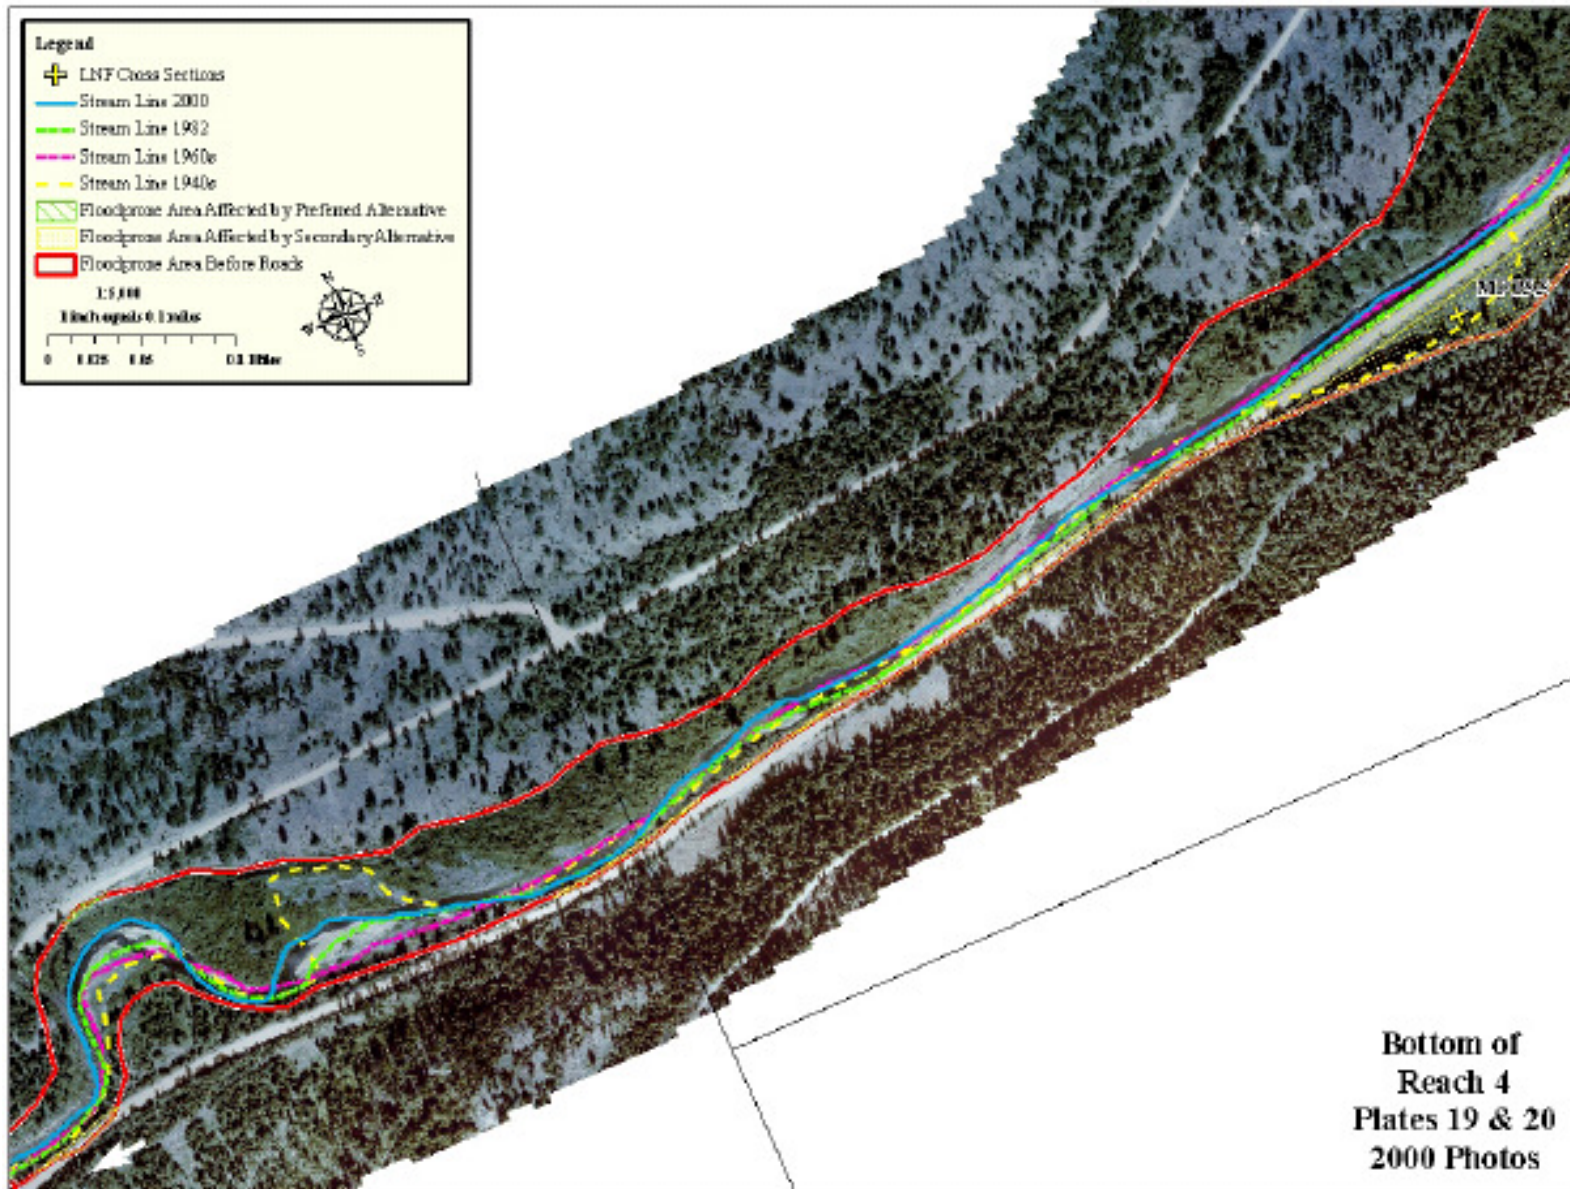
Figure 15. Channel changes over time in the lower portion of Reach 4.

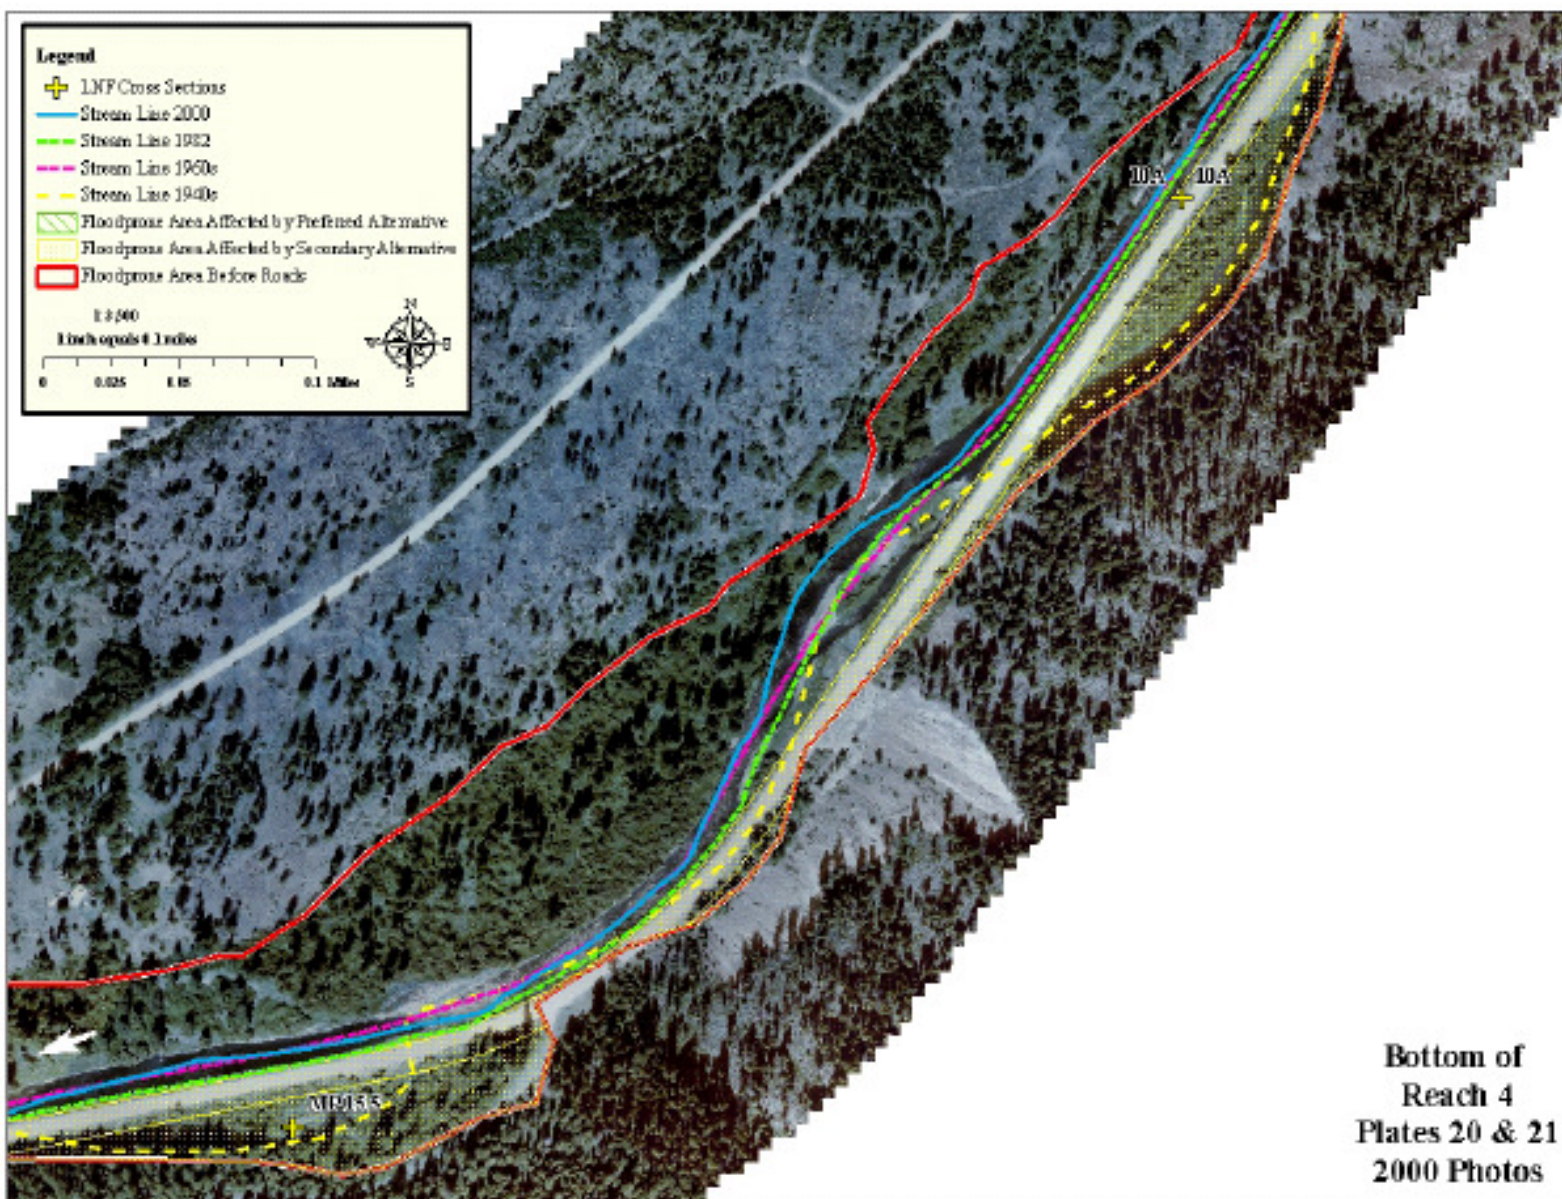
Figure 16. Channel changes and meander cut-offs over time in the lower portion of Reach 4.

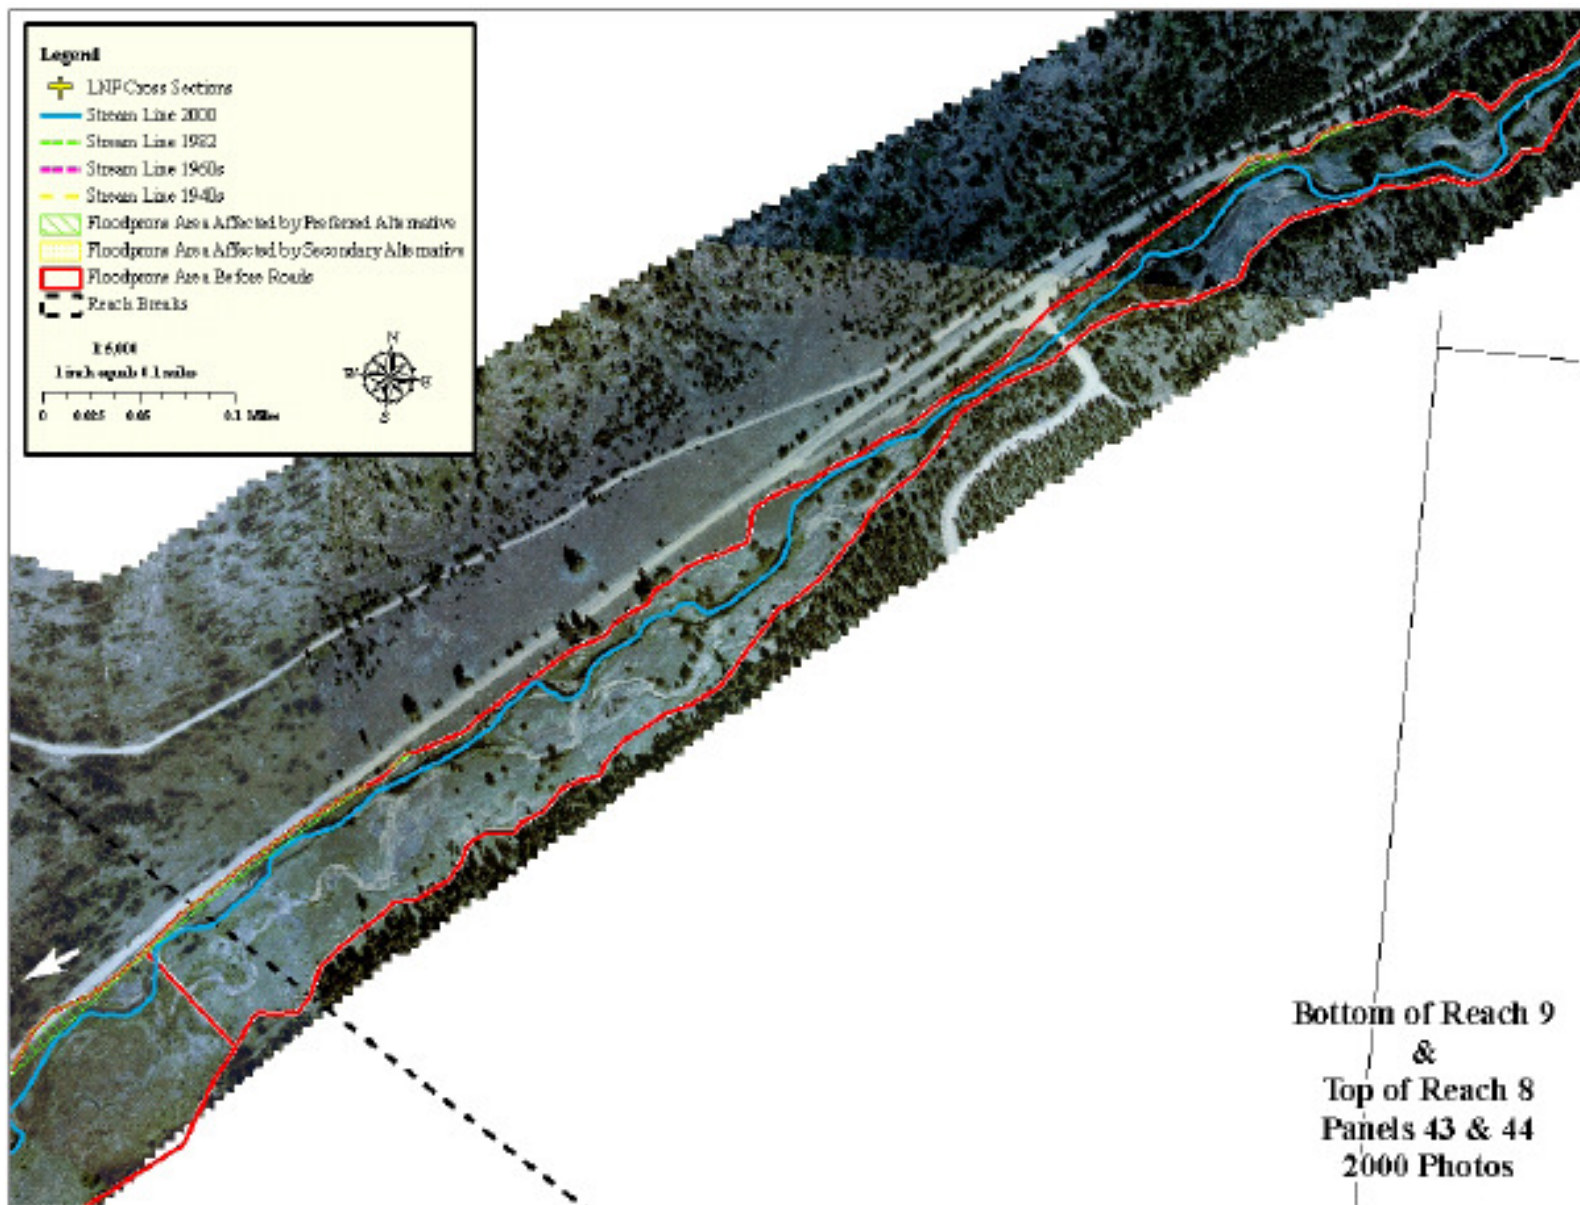
Figure 17. Stream channel alignment from the 2000 photo series. More sinuous historical channel location also apparent.

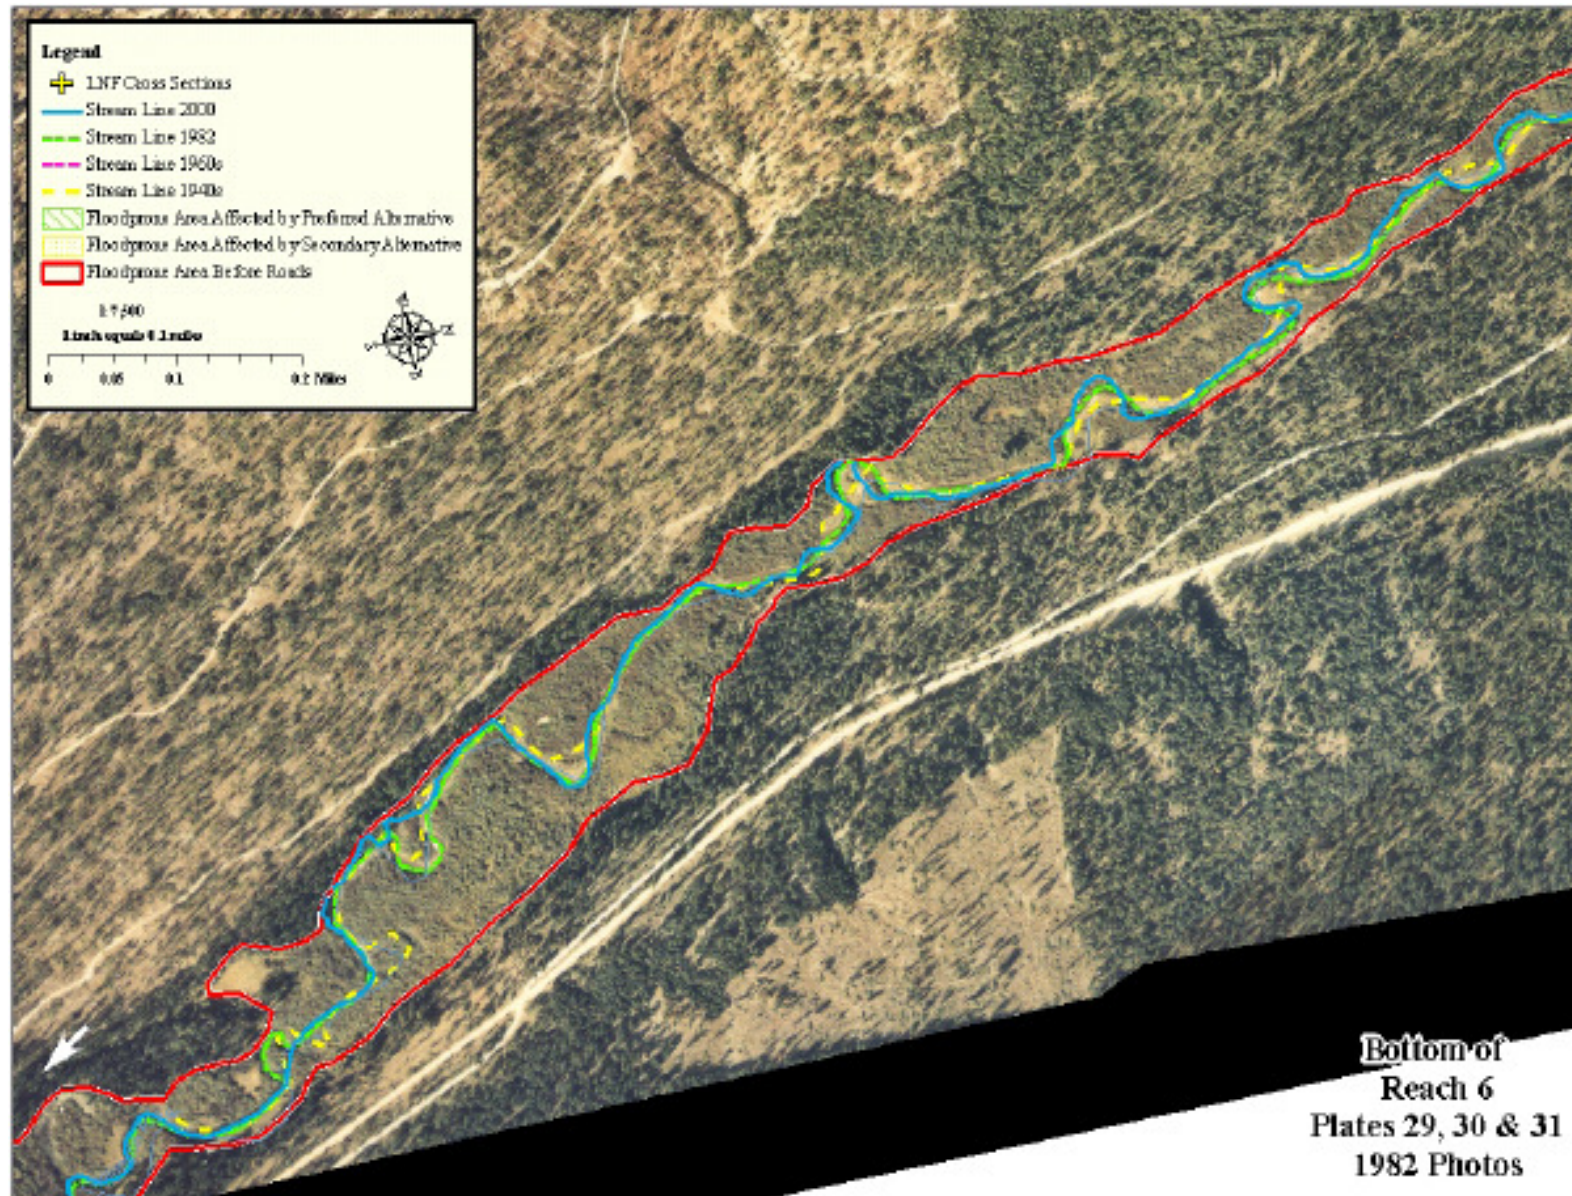
Figure 18. Changes in channel length (and sinuosity) in the lower portion of Reach 6; an example of natural channel function and meander development. Road impacts appear minimal.

As subsequently described, road encroachment in Reach 6 is lowest out of all reaches analyzed. Other indicators suggest that stream and floodplain function is greatest in Reach 6. Relatively low road encroachment in reaches 5, 7, 8, and 9 is also associated with higher sinuosity and greater percent pools. Road encroachment is greatest in reaches 1 through 4, where sinuosity and percent pools is lowest.
